D4L102 QUENCH TESTS

11-May-2004
J. F. Muratore
Brookhaven National Lab

D4L102 QUENCH SUMMARY

Magcool Bay C

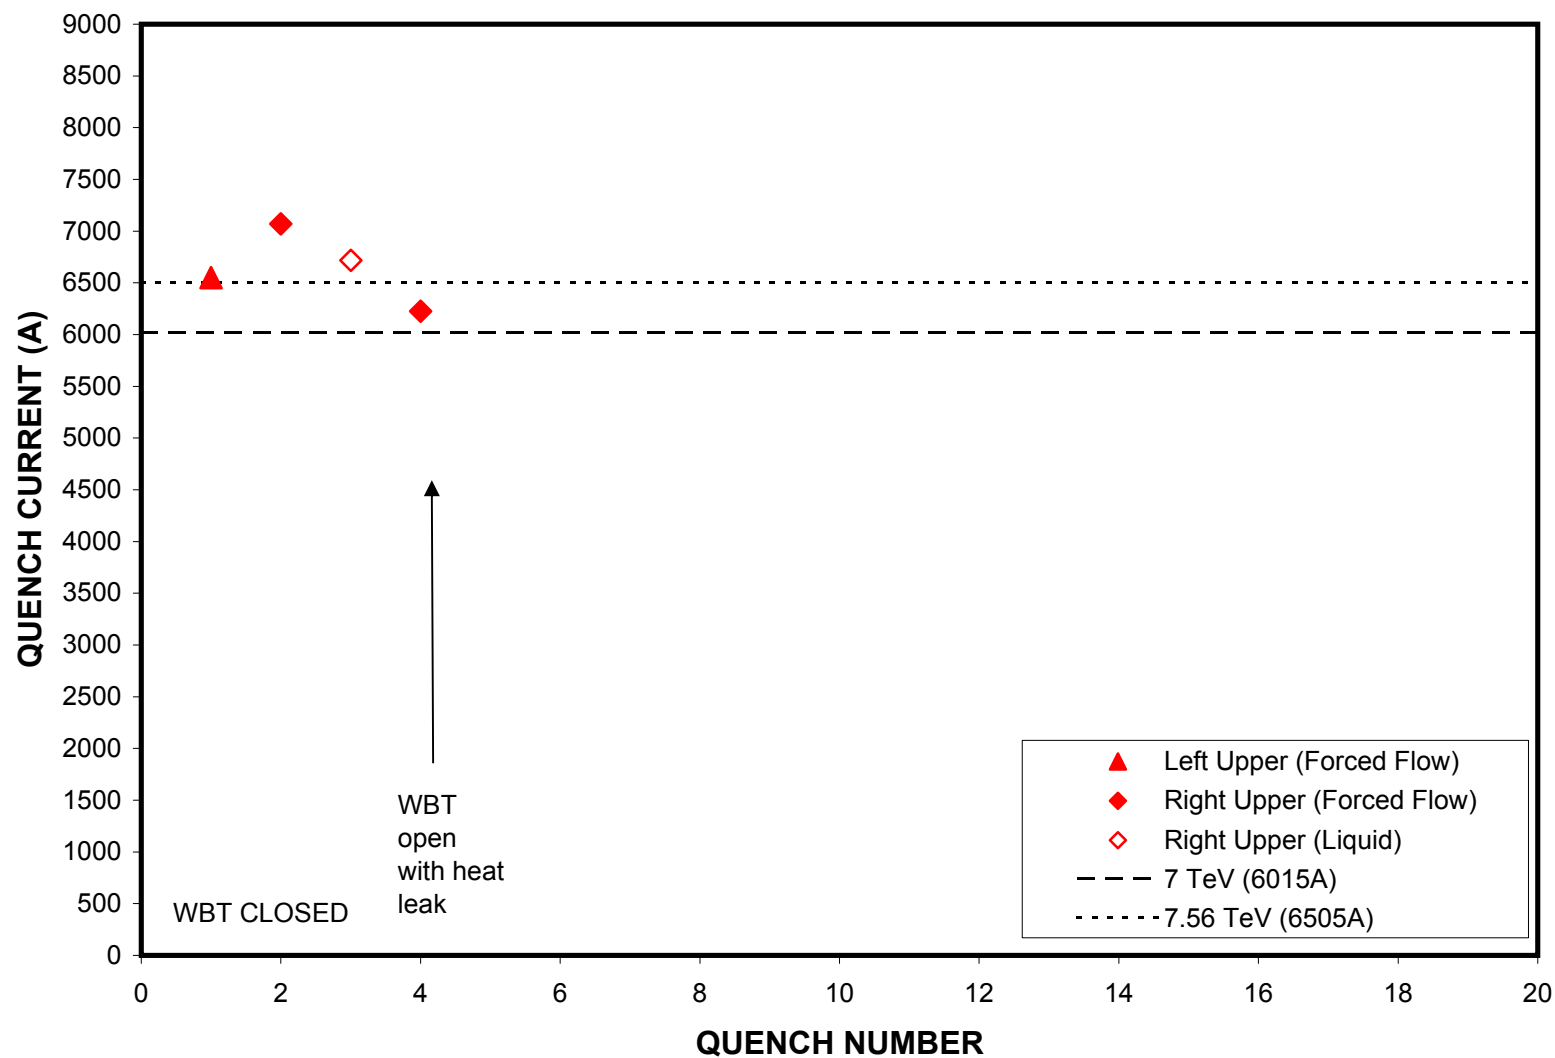
QUENCH #	RUN #	CURRENT (A)	T1 (K)	T3 (K)	START (ms)	MIITS	COIL	COMMENTS
T = 4.5K (nom)								
Warm bore tubes installed, sealed, and under vacuum								
Forced flow cooling @ 12atm								
1	14	6549	4.572	5.118	-44	10.0	upper left	
2	15	7071	4.654	5.284	-14	9.1	upper right	
Switched to liquid helium bath cooling @ 1.4atm								
Warm bore tubes sealed and under vacuum								
3	16	6717	4.609	4.584	-14	7.5	upper right	(i)
Switched back to forced flow cooling @ 12atm								
Warm bore tubes open								
4	18	6226	4.773	5.333	-14	8.0	upper right	(j)

- For quench 3, the left upper coil also quenched, at +49ms (63ms after the right upper). This would explain the low miits generated here.
- Quench 4 occurred during a ramp to 6400A at 10A/s for the first AC cycle before the start of field measurements. We have strong evidence that this quench, with the warm bore tubes open and at room temperature, was caused by residual heat from the bore tube. The bore tube of the coil that quenched (right aperture) had been shown earlier in the day to have an inadequate insulating vacuum. The valve connecting from the vacuum pump had been closed

and the temperature inside the bore tube was abnormally cold. This had been corrected hours before start of the ramp and all parameters looked nominal by ramp start. But there must still have been residual heat left to cause the quench. By the time the system recovered after the quench, the system had returned to nominal temperatures and there were no more quenches during repeated ramps to 6400A during field measurements. In addition, an inspection of all the signals from the quench had shown no electrical anomalies. It was therefore decided that further quench tests were unnecessary.
